**Assessing public outdoor drinking fountain
prevalence and quality:
Using outdoor field observation in playgrounds**

**George Thomson, Nick Wilson
University of Otago, Wellington**

August 2017

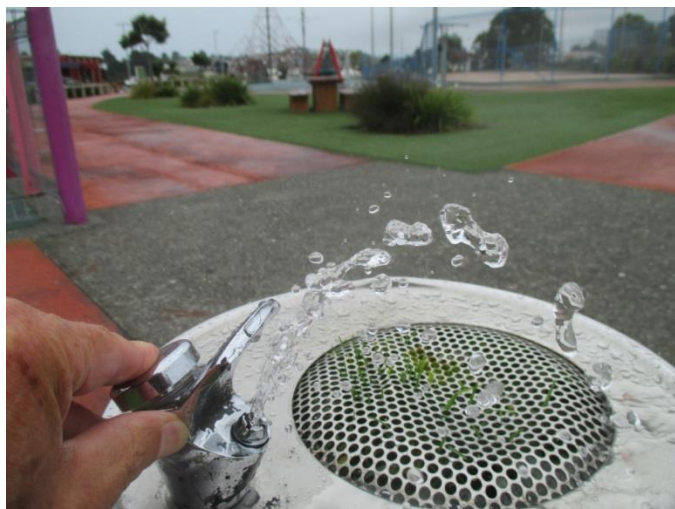
Figure 1: Poorly maintained fountain with grass growing in the drainage sink

Of the 11 working fountains, nine (82%) had side taps for filling water bottles or bowls (eg, see Figure 2), but none had attached bowls for dogs to drink from (in contrast to other drinking fountains we have seen elsewhere in New Zealand). From the lack of tarnish, scratches, and other evidence, all the fountains appeared to be less than ten years old, and had no evidence of vandalism. The flow from all the working nozzles was good (the water spout was more than 10cm from the nozzle). The water stream was sufficiently smooth for easy drinking in all cases, with the stream in Figure 1 being the most marginal case. The working fountains appeared to be well maintained, with the grass growing out of one (see Figures 1 and 2) an exception.

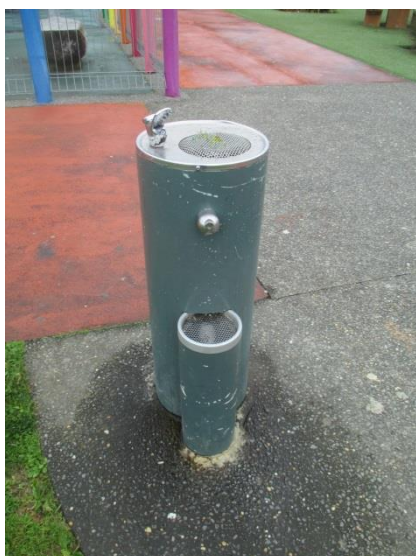
Figure 2: Example of fountain with side tap

There were two additional design features found that could affect the fountains' use. First, fountains varied in the type of nozzle surround used, so as to help prevent lip contact or damage to the nozzle (eg, see Figures 2, 3 and 4). The nature and extent of

such surrounds appeared to affect the ability to clean around the nozzle, to allow sunlight exposure, and to increase the likelihood of discolouration. Second, some fountains did not sufficiently collect the waste water from the drinking nozzles or side taps, and/or did not have suitable surfaces for the water to drain away, resulting in soft, wet or muddy ground around the fountain (eg, see Figures 2 and 4).

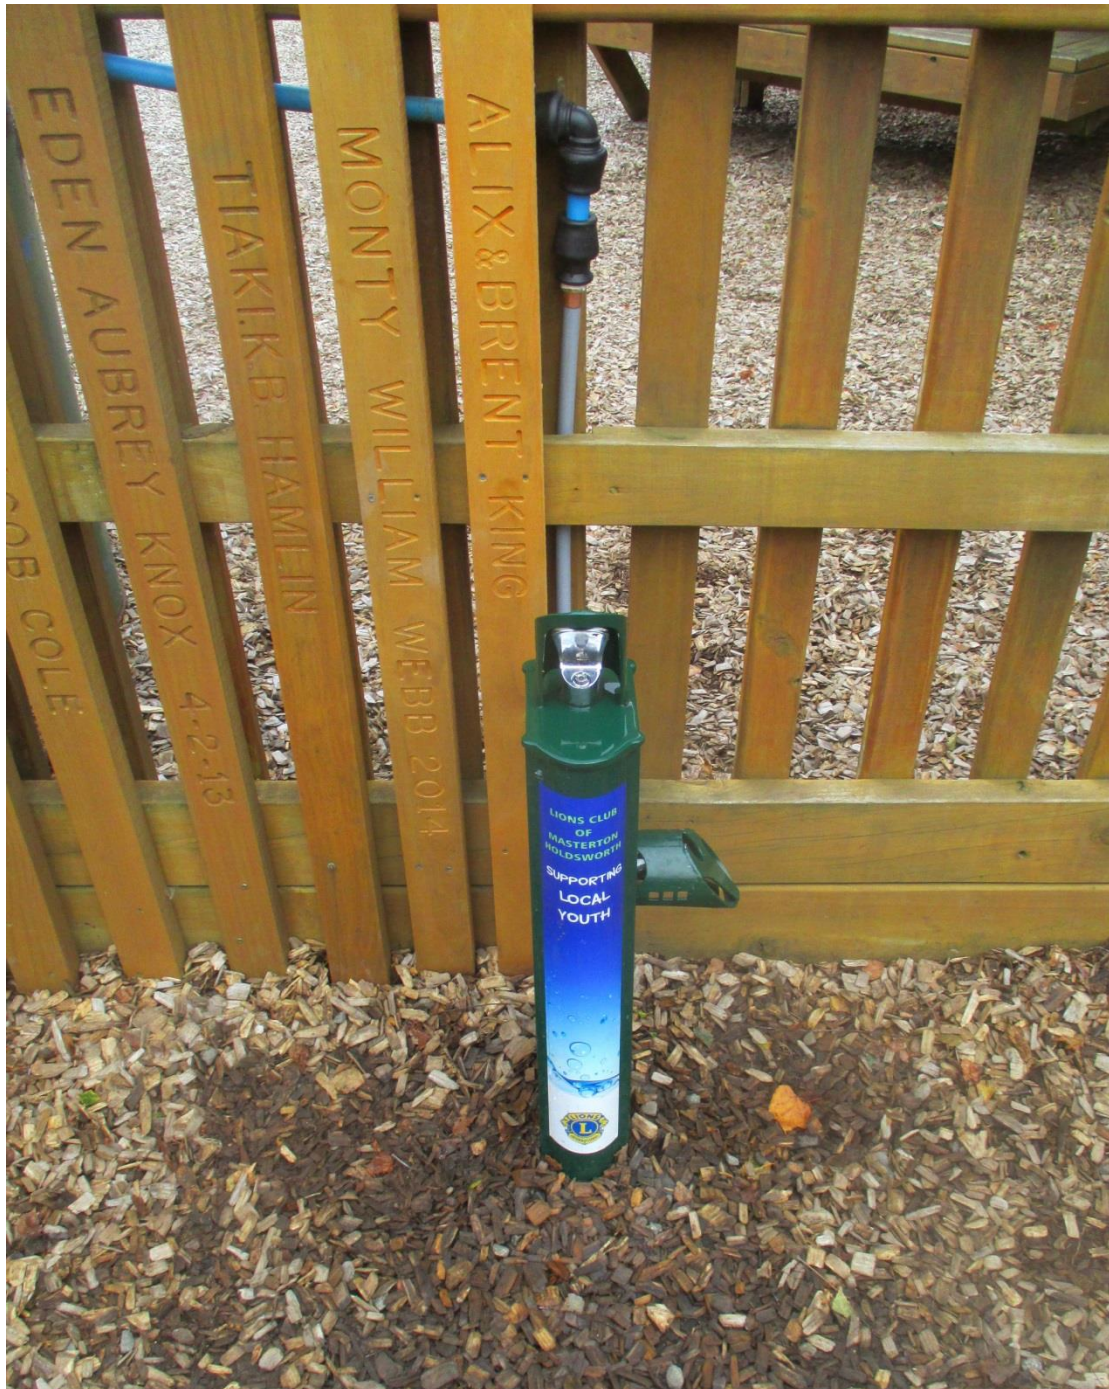
Three fountains had discolouration on the metal surround (eg, from biofilm) within 1 cm of the nozzle of the fountain (see Figure 3). One fountain in the small child area of a playground was less than 70cm high (see Figure 4), and there was no regular sized fountain found anywhere around that playground. No signs were found around any of the playgrounds which indicated the presence of drinking water fountains.

Figure 4: Drinking water fountain designed for under-five year children (there were other fountains in the playground)
